NACA RM E54K29

AXIAL-FLOW COMPRESSOR ROTATING-STALL AND ROTOR-  
BLADE VIBRATION SURVEY

By Howard F. Calvert, Arthur A. Medeiros, and  
Floyd B. Garrett

Lewis Flight Propulsion Laboratory

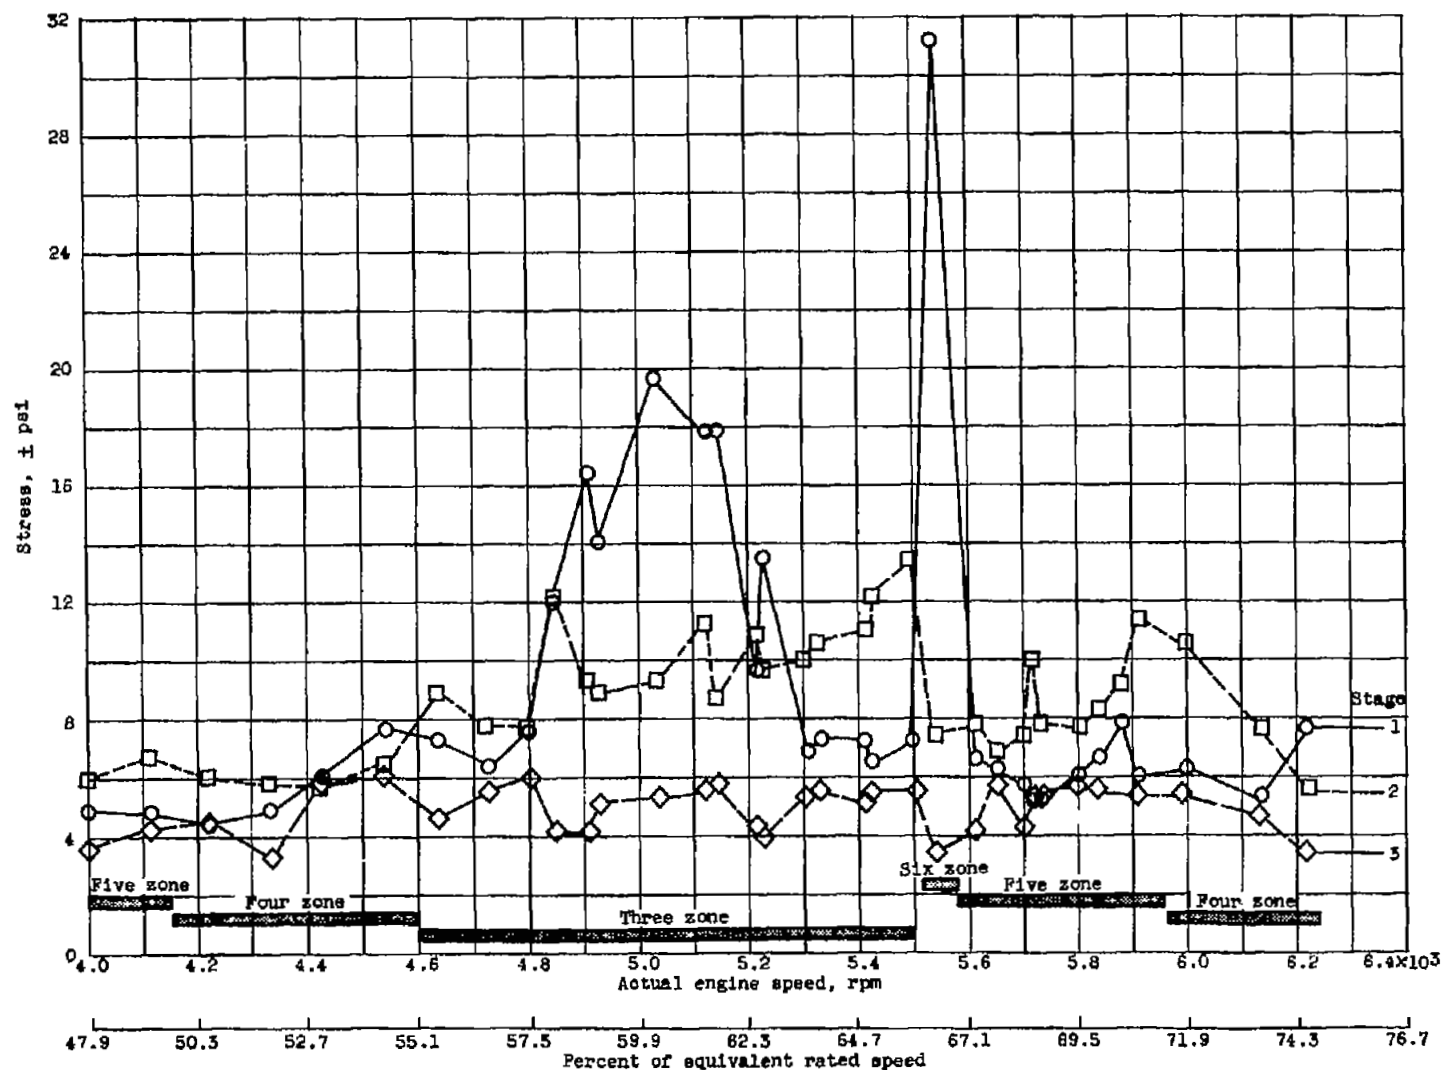
(a) Closed exhaust nozzle.

Figure 3(a) is a plot of vibratory stress against actual engine speed and percent of equivalent rated engine speed. A vibrating blade is affected by the actual speed; therefore, the vibration data will be discussed in terms of actual speed. The percent of equivalent rated speed can be used to locate the rotating-stall data on the performance curve in figure 2(a). Complete compressor data were not obtained for these data points. The data for this figure were obtained with the compressor operating with reduced nozzle area. At the bottom of the curve in figure 3(a) is a bar graph presenting the detailed rotating-stall data. As the compressor speed was increased, the stall-zone sequence was 5, 4, 3, 6, 5, and 4. The three-zone stall was the strongest and persisted over the longest speed range. At approximately 6240 rpm (74.5 percent of rated equivalent speed) the compressor was free of rotating stall.

An examination of figures 3 and 4 indicates that the peak stresses existing at approximately 5000 rpm occurred at the point of intersection of the blade frequency line, and the line representing twice the relative frequency of the three-zone rotating stall. The peak stress of  $\pm 31,200$  pounds per square inch (fig. 3(a)) was excited by a six-zone rotating-stall pattern. This stall pattern was observed over an extremely short speed range.

Figure 3. - Vibratory stresses and rotating-stall patterns measured in first three stages.

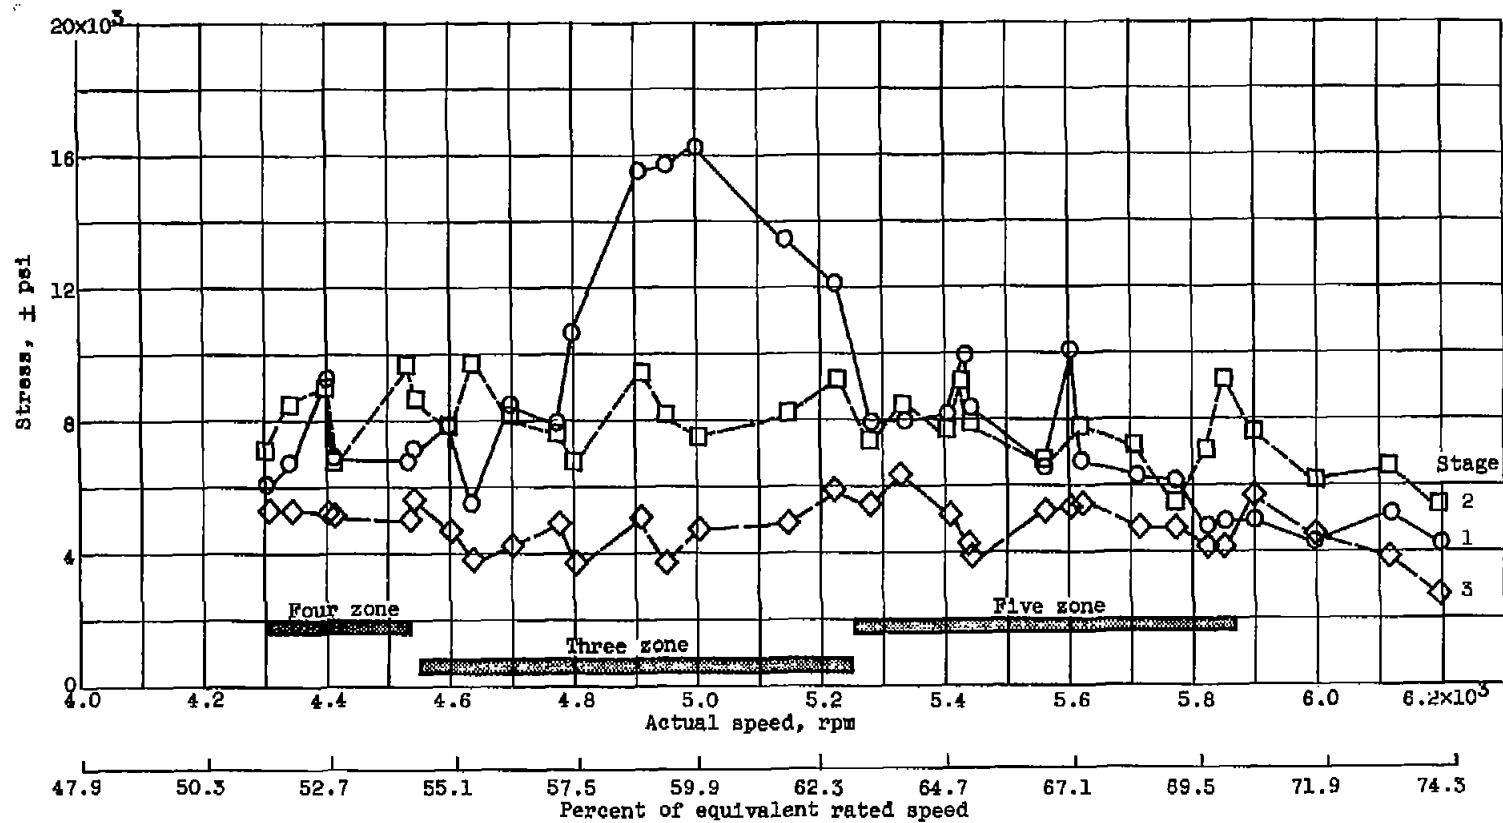
(b) Open exhaust nozzle.

Figure 3(b) is a plot of vibratory stress against actual speed and percent of equivalent rated engine speed. These data were obtained with the compressor operating on the open-nozzle line of figure 2(a). At the bottom of the curve is a bar graph presenting the detailed rotating-stall data. As the speed was increased, the stall zone sequence was 4, 3, and 5. As in figure 3(a), the three-zone pattern was the strongest and persisted over the longest speed range. At approximately 5870 rpm (70 percent of equivalent rated speed) the compressor was free of rotating stall. The operations of the jet engine with the reduced nozzle area or the compressor closer to the stall line increased the severity of the stall, the rotating-stall speed range, and the number of patterns. The six-zone pattern was observed only while operating with the minimum exhaust area.

In figure 3(b), with the compressor operating on the open-nozzle line, the first stage again had a peak stress at approximately 5000 rpm appearing with a three-zone stall. No peak stresses were observed at 5500 rpm because the six-zone stall was not present.

Figure 3. - Concluded. Vibratory stresses and rotating-stall patterns measured in first three stages.

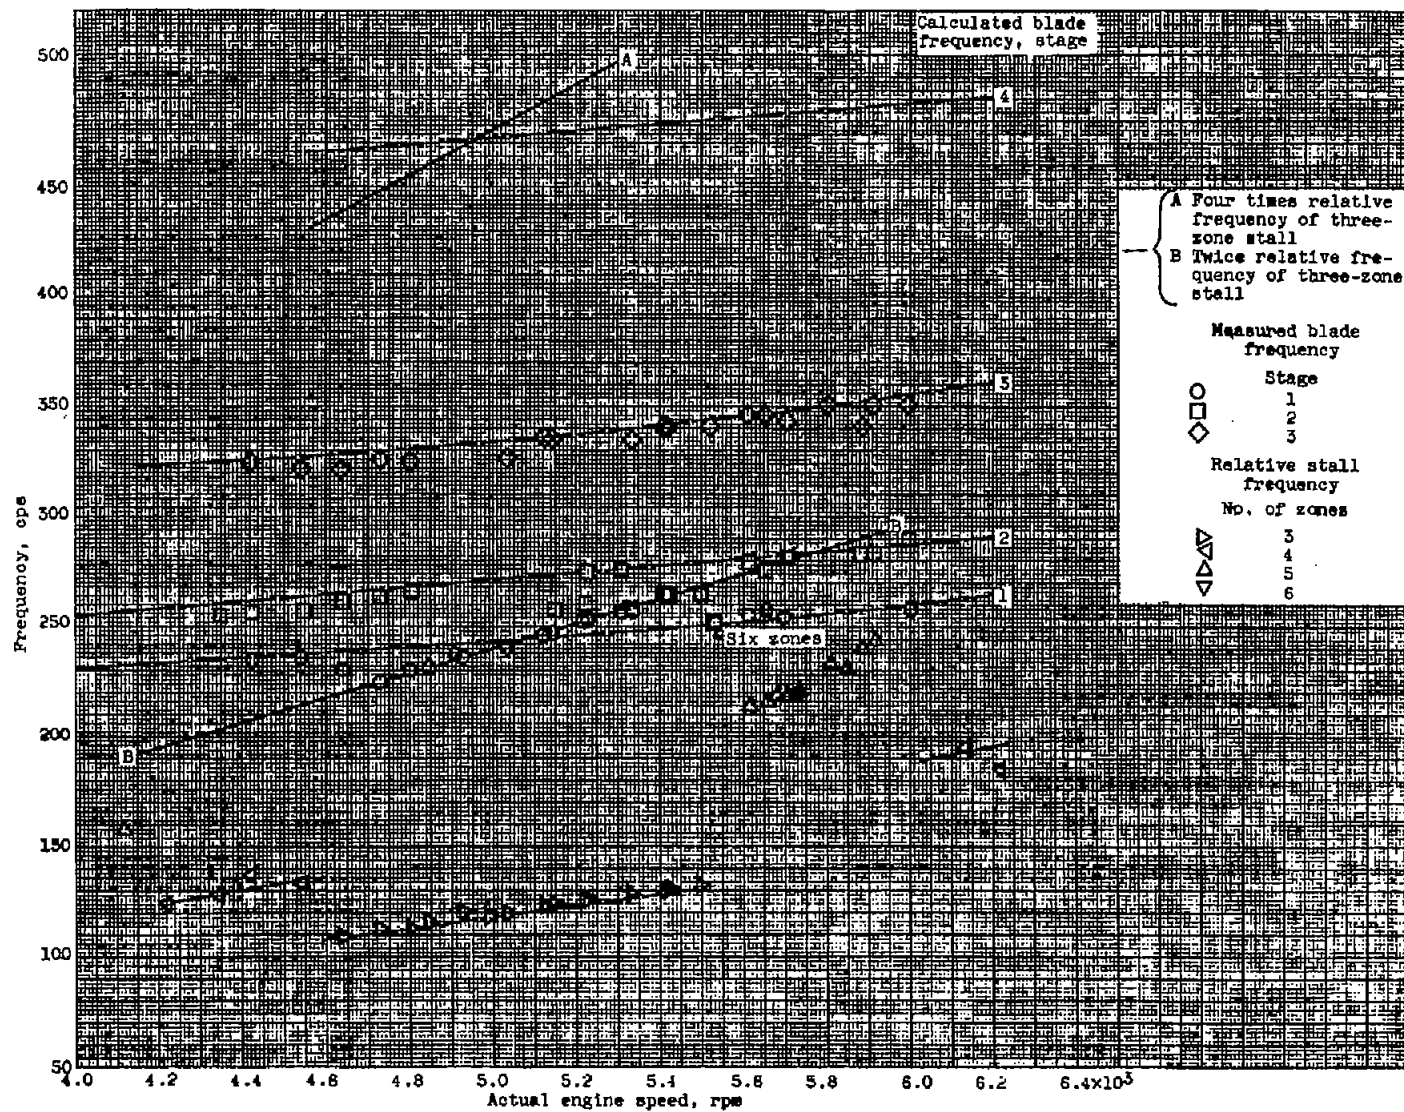
Figure 4 is a plot of frequency against "actual" engine speed. The dashed lines represent the natural bending frequencies for the first- to fourth-rotor stages corrected for the effect of centrifugal force (ref. 5). The lower series of data points represents the relative stall frequencies for the three-, four-, five-, and six-zone rotating stall over the range of speeds observed. The frequency of excitation due to rotating stall for a rotor blade is the stall frequency relative to the rotor blades. The relative stall frequency is defined by the following equation:

3561 The upper series of data points represents the actual measured blade vibration frequencies for the first three stages. Over most of the speed range, the blade frequencies followed the dashed lines representing the static frequency corrected for the effect of centrifugal force. However, over the speed range of from approximately 4700 to 5700 rpm, the first-stage blades followed a line "B" representing a frequency equal to twice the relative stall frequency for the three-zone stall. Over a speed range of from 5300 to 6000 rpm, the second-stage blades also followed this two times three-stall line. These first- and second-stage blades were being forced to vibrate by the three-zone rotating stall. In reference 2, the first- and second-stage blades were also forced to vibrate at twice the relative frequency of the three-zone rotating stall and not their own natural frequencies. However, an exception did occur at approximately 5540 rpm (fig. 4). At this point the first- and second-stage blades were forced to vibrate at the frequency of a six-zone rotating stall. Shown in figure 3(a) are the stress data for the first three stages as the compressor was operating on the reduced-nozzle line in figure 2(a). The first stage had peak stress values of  $\pm 19,000$  and  $\pm 31,200$  pounds per square inch at approximately 5050 and 5540 rpm, respectively. The first peak stress was observed with a three-zone stall and the second peak with a six-zone stall. The stresses observed in the second stage were considerably lower than for the first stage. The average stress of the many peaks between 4800 and 6000 rpm was approximately  $\pm 12,000$  pounds per square inch. The three- and five-zone stalls were observed with these vibrations. No stresses over  $\pm 6000$  pounds per square inch were observed in the third stage.

Line A representing a frequency four times the relative stall frequency of a three-zone stall (fig. 4) intersects the fourth-stage blade frequency at approximately 4950 rpm. At this intersection, resonance would occur between the blades and rotating stall. Since strain gages had not been installed on the fourth stage, no blade vibration was recorded; however, it can be assumed that the fourth-stage blades would respond to the three-zone rotating-stall excitation as did the first and second stages (fig. 3).

Figure 4. - Rotor-blade and rotating-stall frequencies for 13-stage axial-flow compressor.

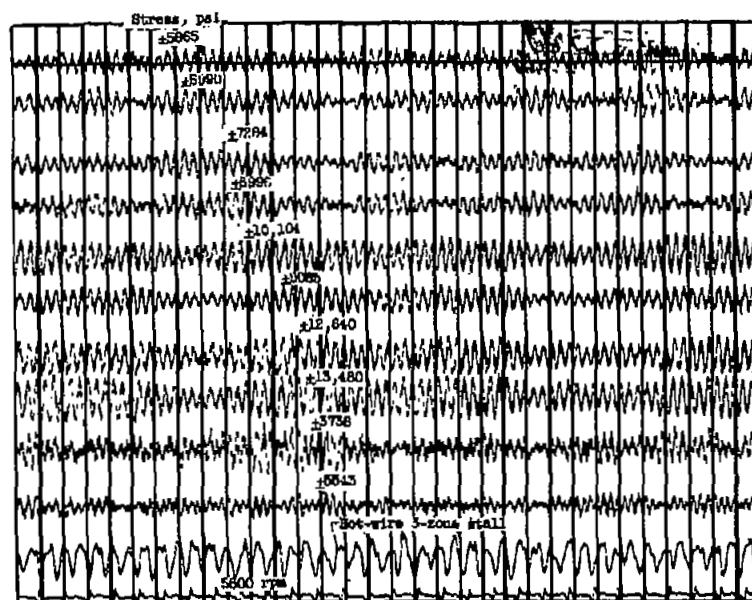
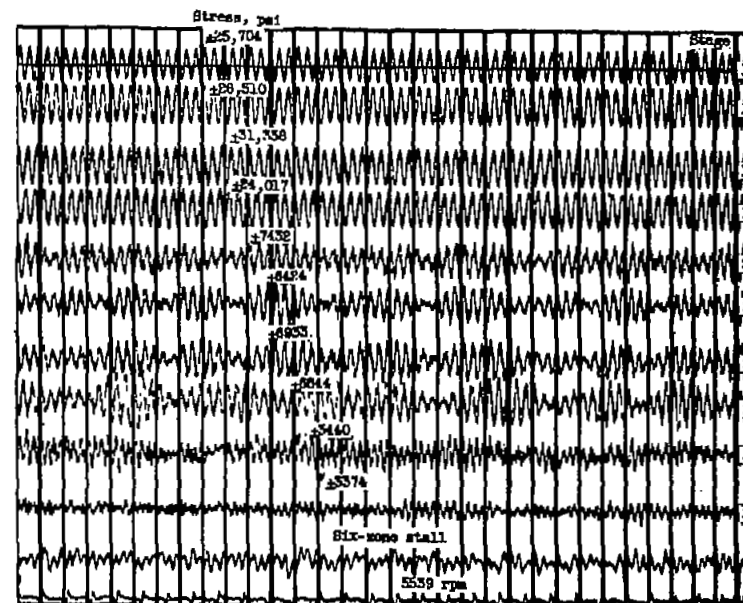
Figure 5 is a reproduction of sections of two oscillograph records. Section A is the record of the blade vibration occurring with a three-zone pattern at 5500 rpm. Here the first-stage blades were vibrating at a low maximum stress of  $\pm 7284$  pounds per square inch. At this compressor speed, the three-zone stall had little effect on the blades, because the relative stall frequency was approximately 15 cycles higher than the natural blade frequency. Section B is a reproduction of the oscillograph record showing the maximum stress recorded in the first stage in this investigation. The compressor speed was 39 rpm higher than that for section A. However, in section B the compressor was operating with six-zone rotating stall. The rotational speed of the six-zone stall was higher than the three-zone stall and, as a result, the relative stall frequency for the six-zone stall was approximately 18 cycles lower than for the two times three stall (fig. 4). This reduction made the relative stall frequency equal to the natural blade frequency. With this fundamental excitation, the exciting forces were high and, as a result, the maximum vibratory stresses were observed.

Figure 5. - Oscillograms of vibration caused by rotating stall.
